Active Errata List

AT89C51CC03

Errata Sheet

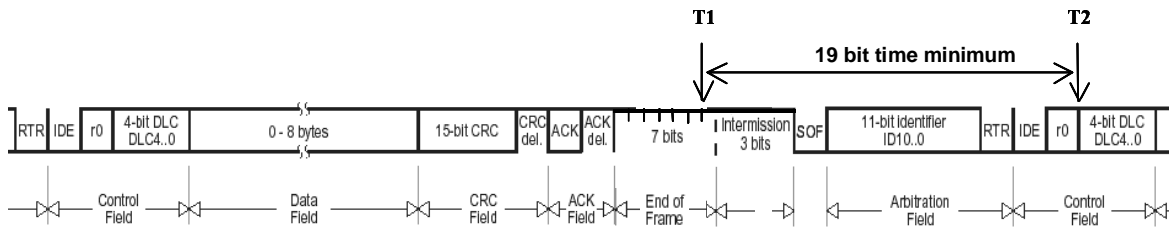
If the transmitter lost arbitration against another node, two conditions can occur :

1. At least one Receive MOB of the chip are programmed to accept the incoming message. In this case, the transmitter will wait for the next 3-bit Intermission to retry its transmission.
2. No Receive MOB of the chip are programmed to accept the incoming message. In this case the transmitter will wait for a 4-bit Intermission to retry its transmission. In this case, any other CAN nodes ready to transmit after a 3-bit Intermission will start transmit before the chip transmitter, even if their messages have lower priority IDs.

Always have a Receive MOB enabled ready to accept any incoming messages. Thanks to the implementation of the CAN interface, a Receive MOB must be enable at latest, before the 1st bit of the DLC field. The Receive MOB status register is written (RXOK if message OK) immediately after the 6th bit of the End of Frame field. This will leave in CAN2.0A mode a minimum 19-bit time delay to respond to the end of message interrupt (RXOK) and re-enable the Receive MOB before the start of the DLC field of the next incoming message. This minimum delay will be 39-bit time in CAN2.0B. See CAN2.0A CAN2.0B frame timings below.
