**CUI INC****Part No: CEP-1106****Description: piezo audio transducer****Date: 9/18/2006****Unit: mm****Page No: 1 of 5**

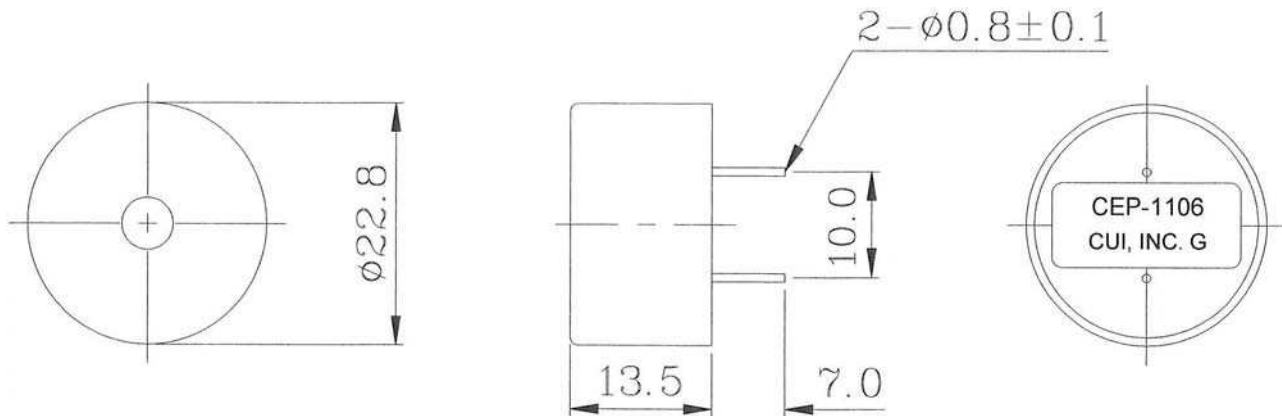
**Appearance Drawing**Tolerance:  $\pm$ 0.5

| Dimensions | $\phi$ 22.8 x H13.5 mm | |

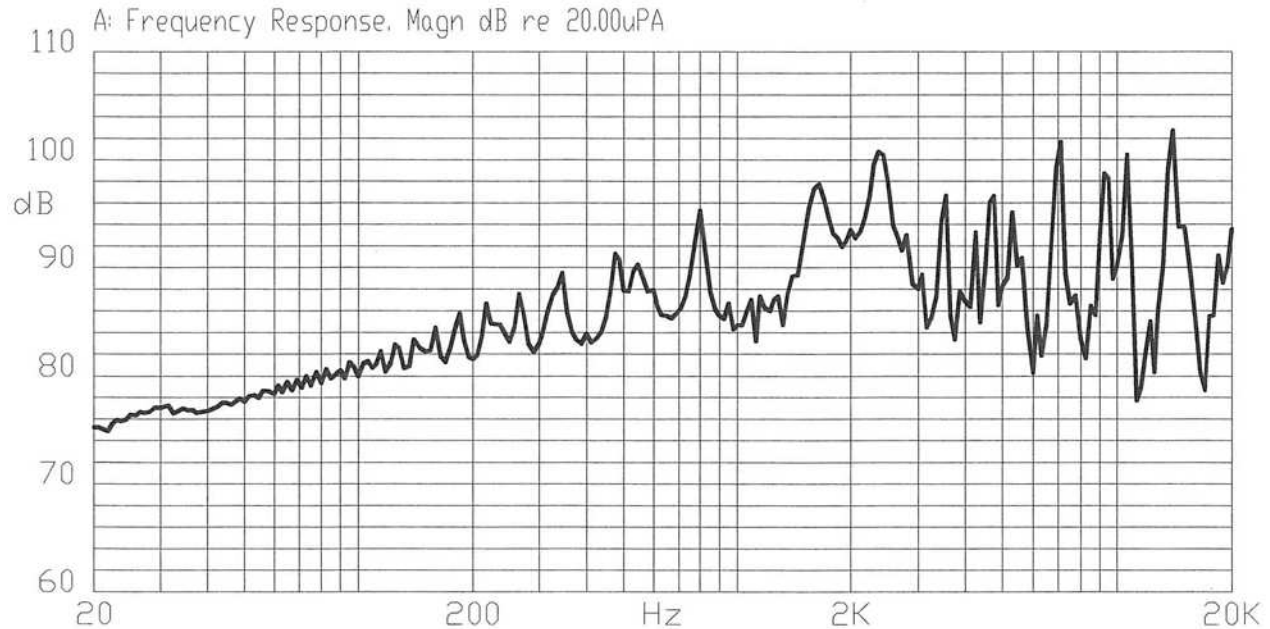
## Typical Frequency Response Curve

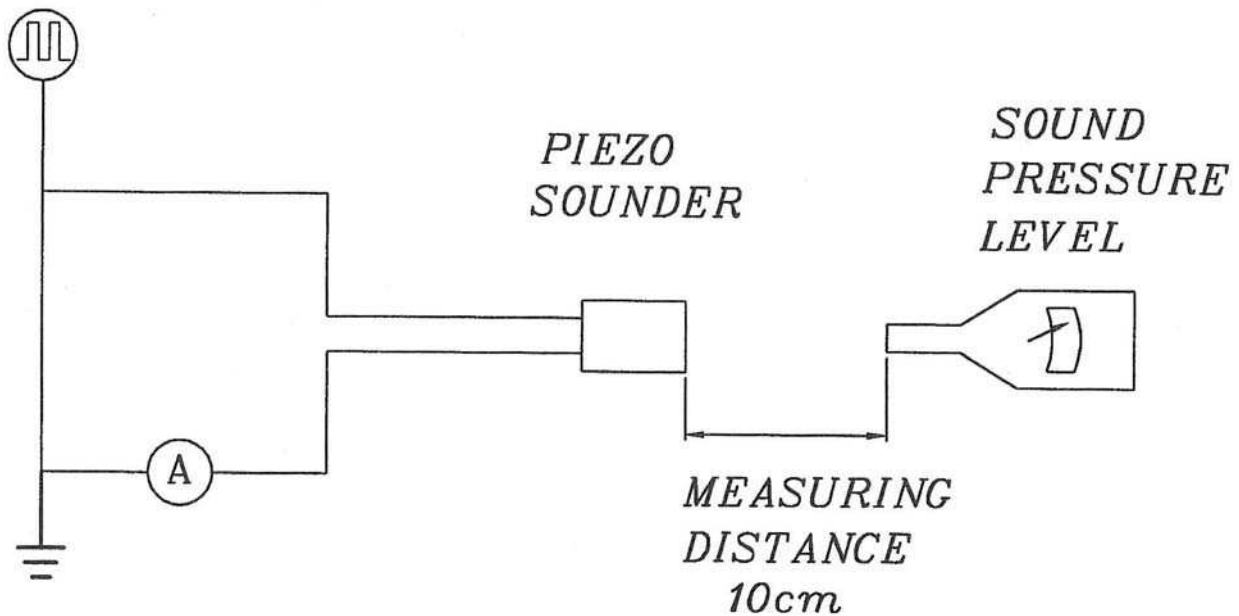
## Measurement Method

S.P.L. Measuring Circuit  
Input Signal: 10 V p-p, 2.4 KHz, Square Wave  
Mic: RION UC 30  
S.G.: Hewlett Packard 33120A Function Generator or equivalent

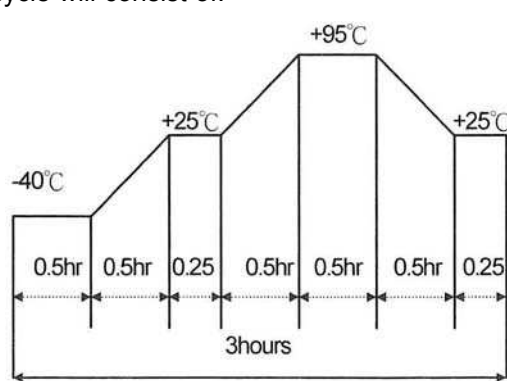
| Item | Test Condition | Evaluation Standard |
|---|---|---|
| Temp. cycle test | The part shall be subjected to 5 cycles. One cycle will consist of:<br> | |

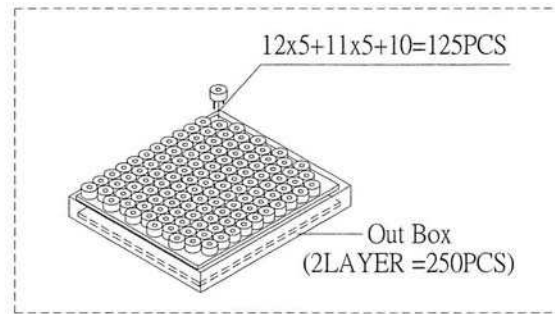
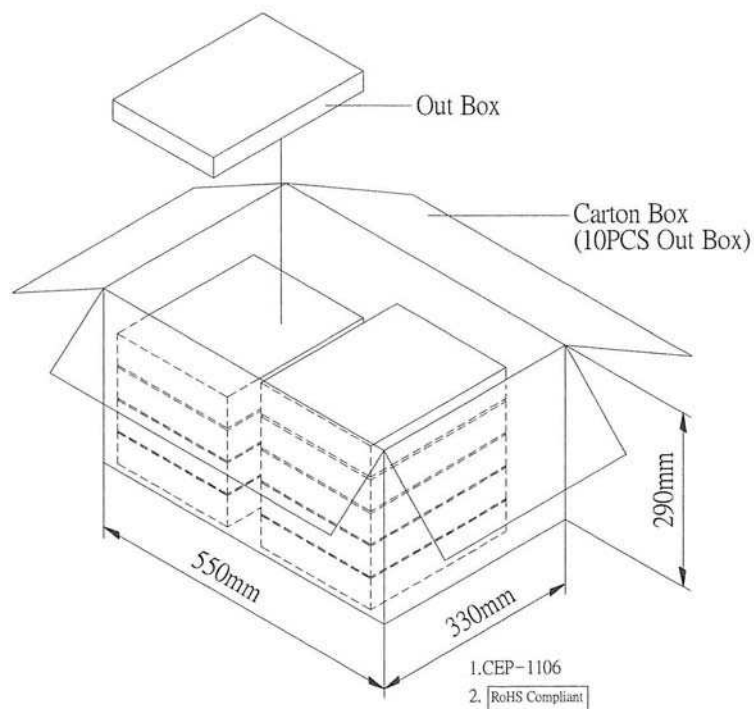
## Packaging

| Out Box | 310mmx248mmx49mm | 2x125PCS=250PCS |
| Carton Box | 550mmx330mmx290mm | 250PCSx10=2,500PCS |
